RELIABILITY TEST REPORT

Report No: 20210308003

Product Description: nRF52840 Bluetooth Module

Testing Required: Thermal Shock Test

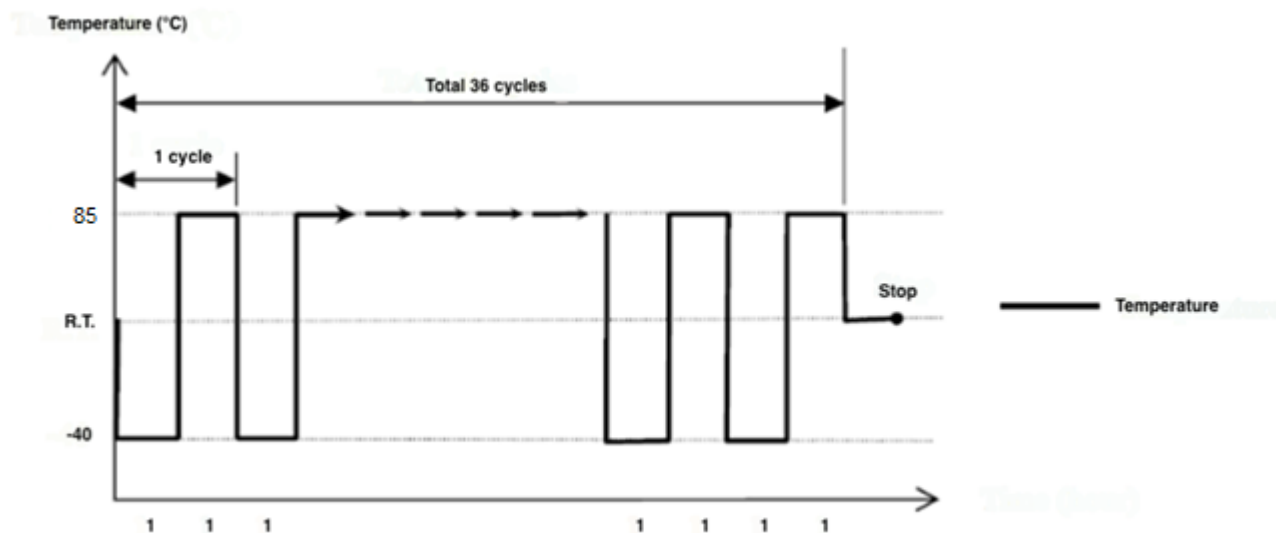
Test method: Refer to JASO D001-94, Clause 5.17

- Sample Condition: Operating
- The temperature transition time shall be within 1 minute.
- Examine the appearance of specimen(s) by visual check and perform functional check during this test.
- Functional check: Connect the specimen(s) with notebook and examine whether the signal transmission could work normally or not.

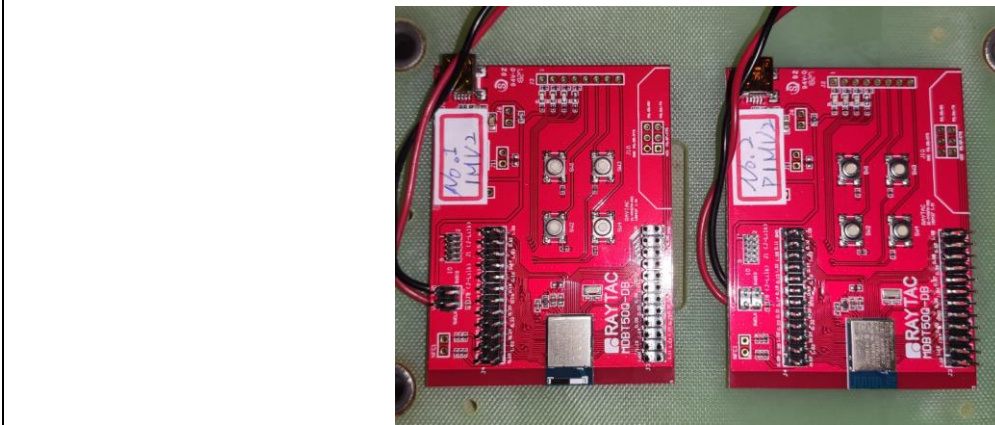
1. Appearance of specimen

Check Item Style/Items No.	Appearance check (Visual check)	Functional Check
MDBT50Q-1MV2 / No.1	No visible damage	No data loss
MDBT50Q-P1MV2 / No.2	No visible damage	No data loss

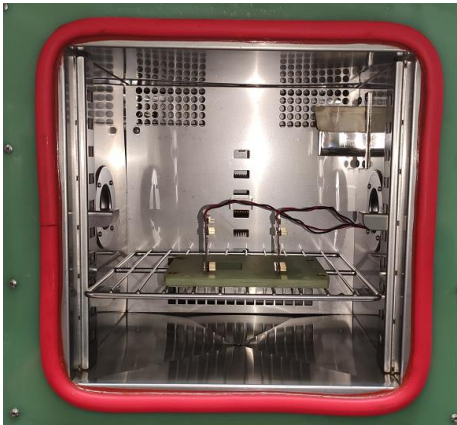
2. Thermal Shock Test

Testing time: 36 cycles * 2 hours = 72 hours

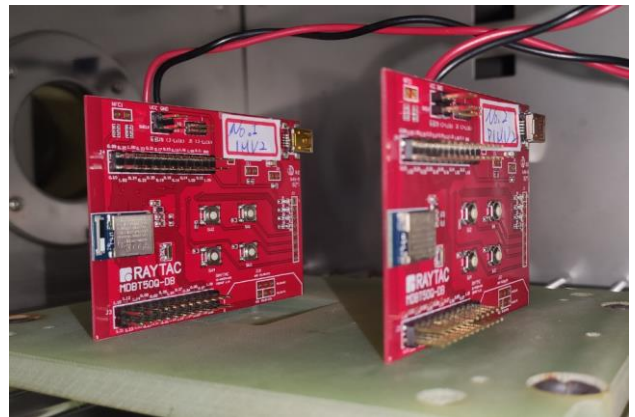
3. Thermal Shock Test

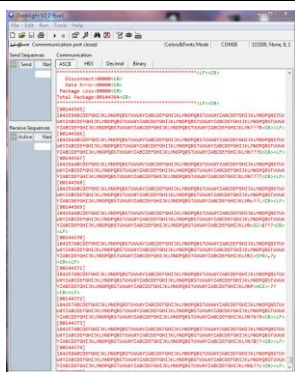
4. Functional check
MDBT50Q-1MV2/No.1

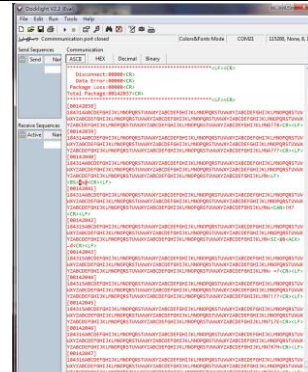
5. Functional check
MDBT50Q-P1MV2/No.2
