RELIABILITY TEST REPORT

Report No: 20210629003

Product Description: nRF52832 Bluetooth Module
Style / Item No.: MDBT42Q-512KV2/P512KV2 / No.1, No.2
Manufacturer/ Vendor: Raytac Corporation
Country of Origin: Taiwan
Testing Required: Thermal Shock Test
Testing Method: JASO D001-94, Clause 5.17
Quantity: Total 2 sets
Testing Period: Jun. 22, 2021 to Jun. 25, 2021
Testing Results: -Please See Attached Sheets

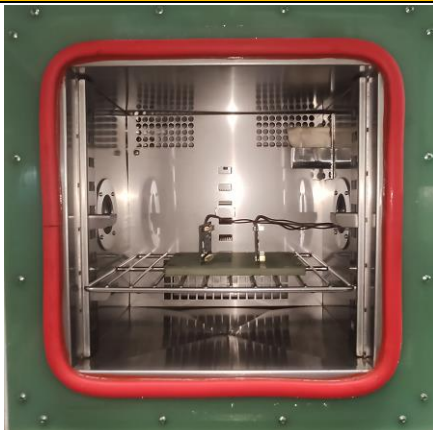
2. Thermal Shock Test
